## History of Walberswick Drainage Mill

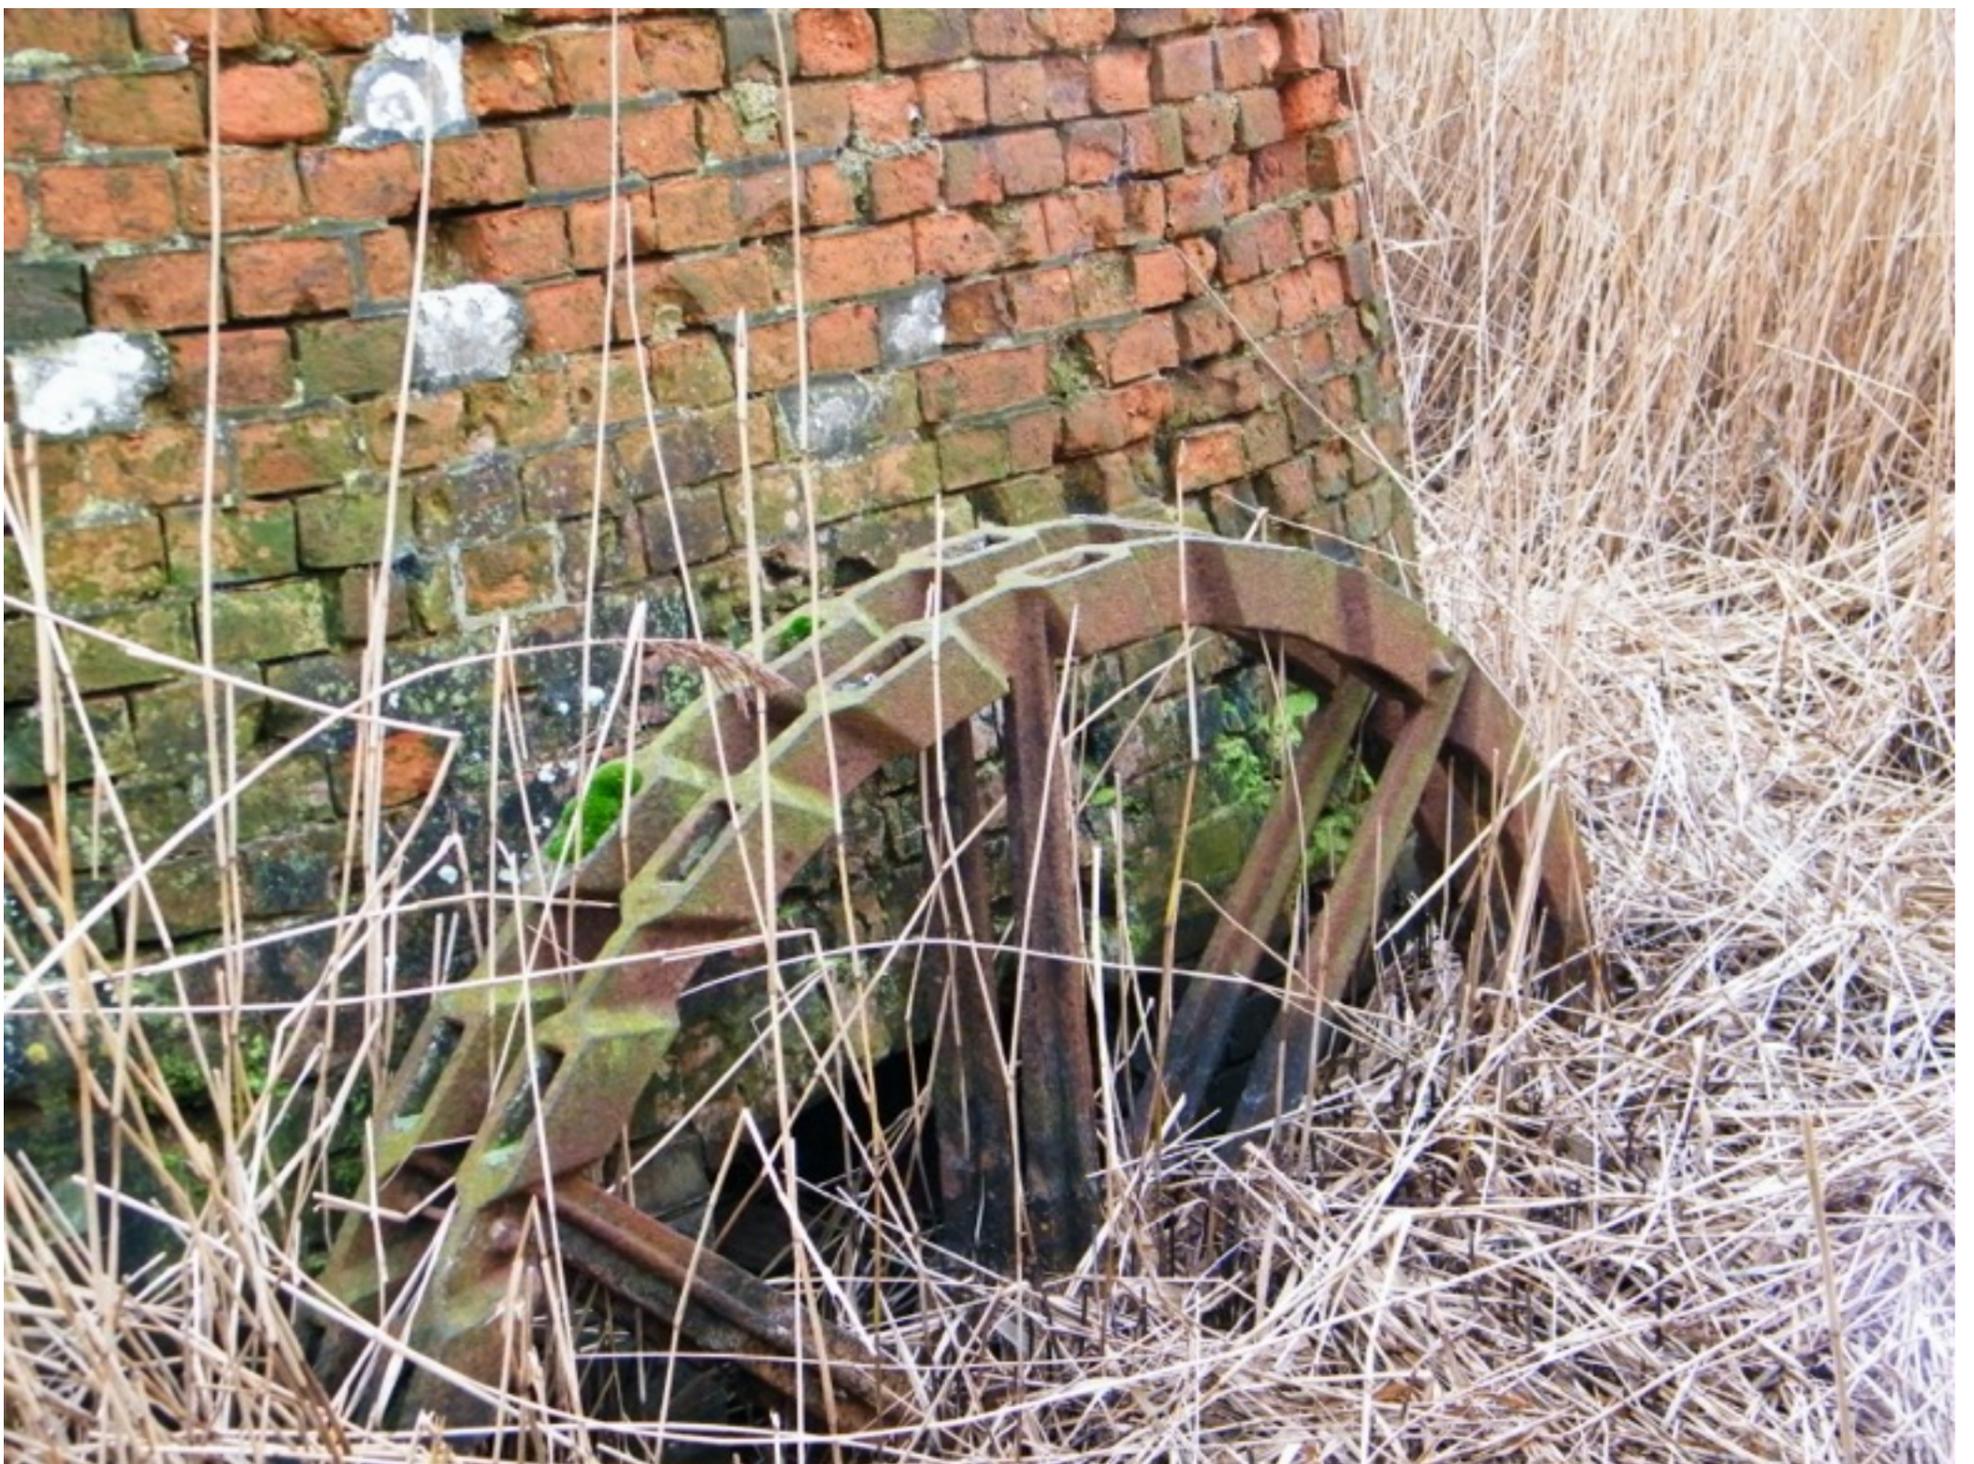
Fig 2–8 Iron ‘spider’ of scoop wheel

The upright (wooden) shaft of the mill survived the fire of 1960, as did the crown wheel, pit wheel and drive shaft (see component parts 6–9 Fig. 2–7). It is to be noted that the Walberswick Mill did not have a fantail (component parts 15 & 16). The components are still in place, as are parts of the floors. Outside the mill, the tailpole and part of the winching gear remain, though the tailpole is in a broken and incomplete state. The dyke alongside the mill has been silted up but the iron ‘spider’ of the scoop wheel is still in place (Fig. 2.8)

Originally, when the wooden paddles were in place, the scoop wheel would have had a total diameter of approximately 3m (Wailes, 1956). A wooden hoodway of boarding would have existed around the outside of the scoopwheel to shield splashes; this hoodway is visible in Fig. 2.11.
